# RECONNAISSANCE REPORT OF DAMAGE TO HISTORIC MONUMENTS IN CAIRO, EGYPT FOLLOWING THE OCTOBER 12, 1992 DAHSHUR EARTHQUAKE

**Reconnaissance Report of Damage  
to Historic Monuments in Cairo, Egypt  
Following the October 12, 1992 Dahshur Earthquake**

Technical Report NCEER-93-0016

August 19, 1993

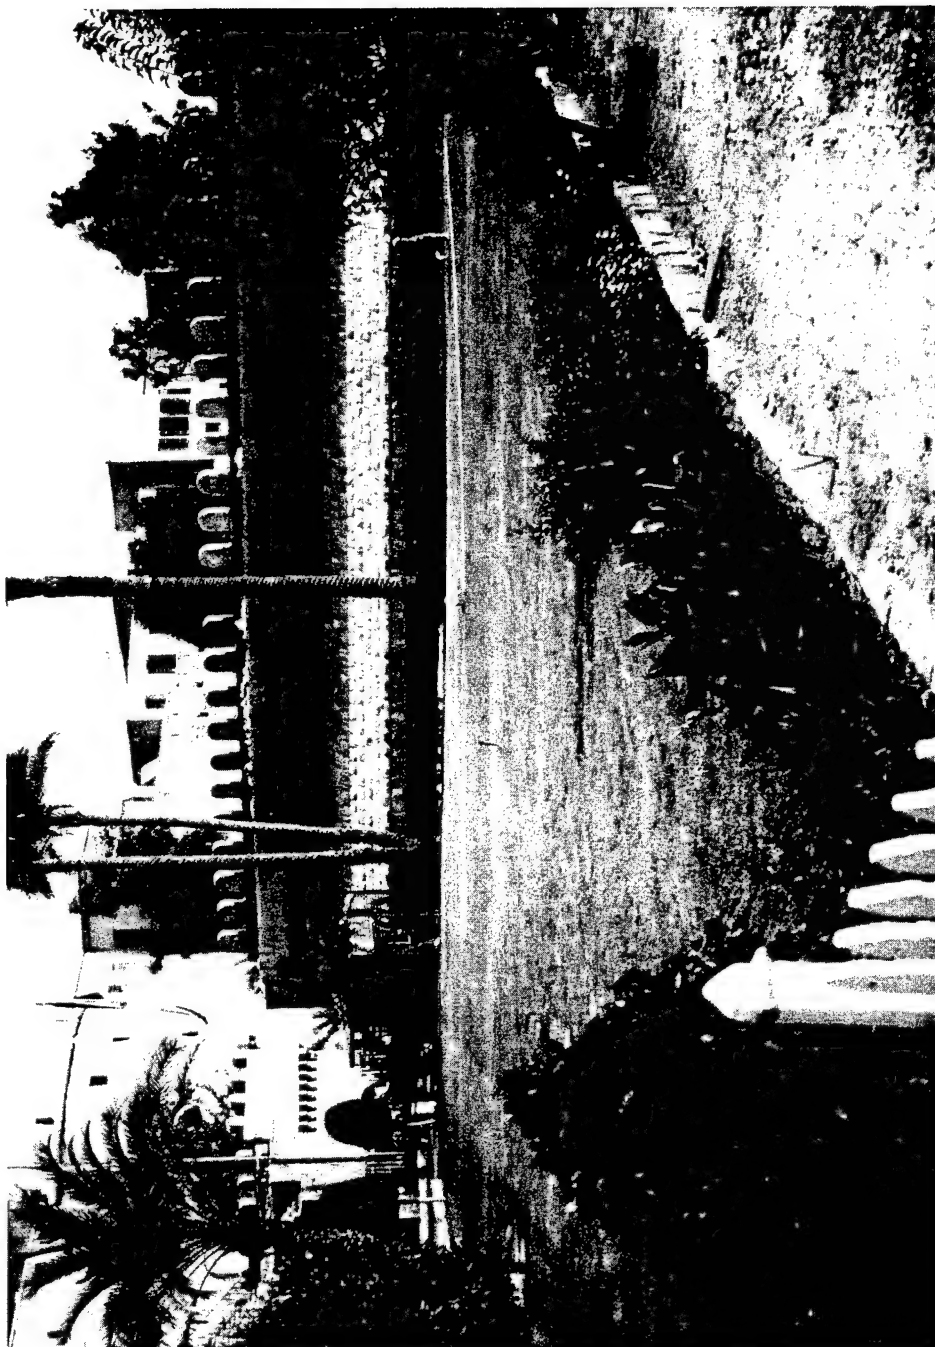
**FIGURE 4-8** Manicured lawn of Citadel in Southern Enclosure looking  
northeast toward Bāb al-Gabal

Watering is also taking its toll on masonry retaining walls at the Citadel. The custodians maintain lush grass, bushes, and trees within the complex as shown in figure 4-8 from extensive watering. These gardens and lawns apparently were created in 1984 (SPARE 1984b). The consequence of watering is the steady seepage of water through the walls of the Citadel. This is clearly evident on the east and west sides. A view of the western portion of the wall is shown in figure 4-9. The preservation of the masonry stone will require a change in the current practice of maintaining the flora at the Citadel or a return to a more historic appearance with drought-resistant plants and trees.

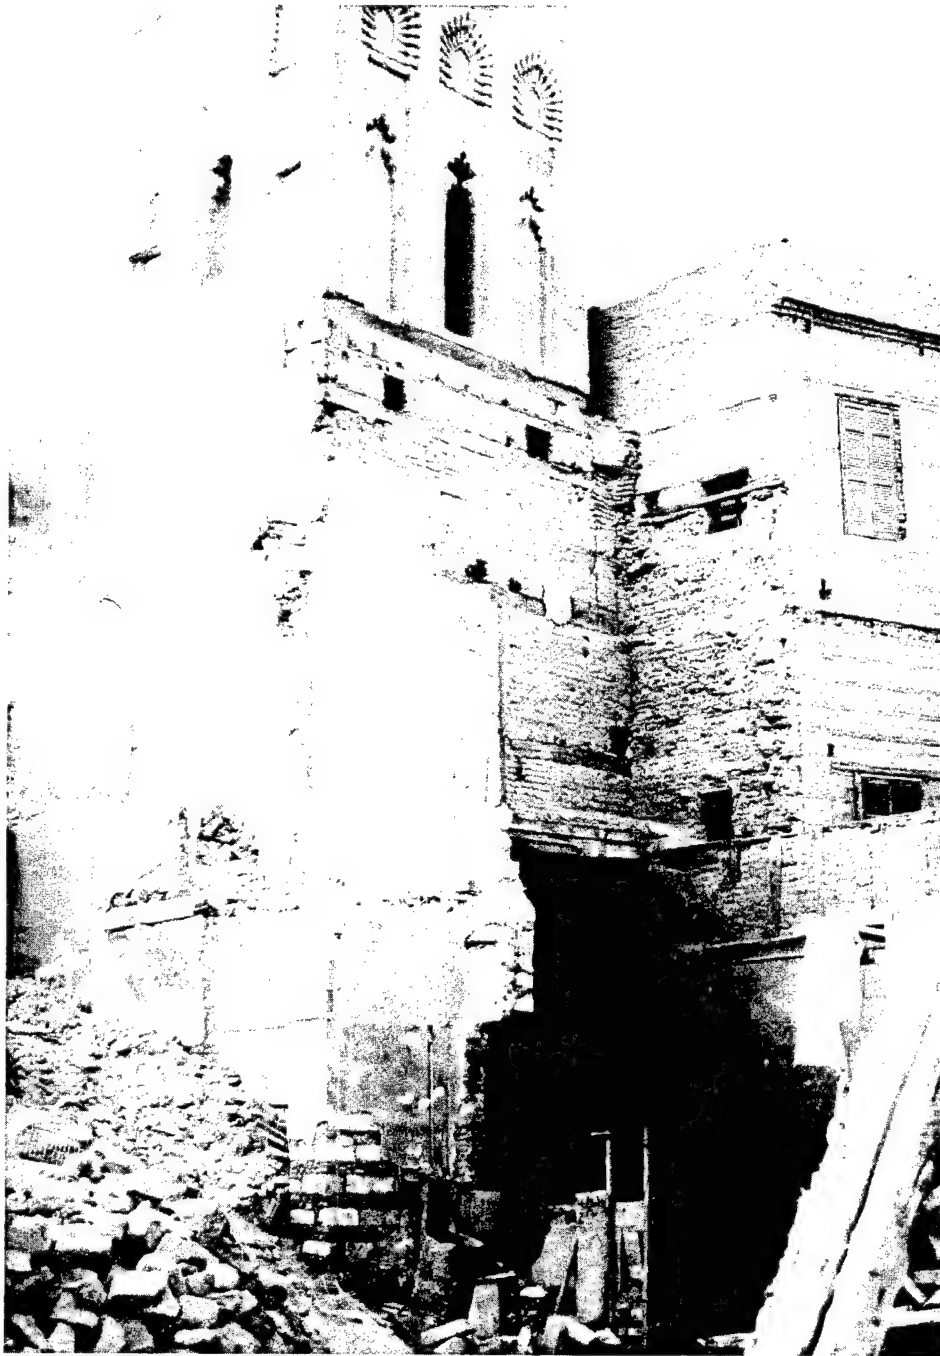
This *mabkhara*-style minaret is about all that remains of the madrasa bearing the same name and is the only minaret of the Ayyubid Period to survive intact (Behrens-Abouseif 1989). Moreover, this minaret is one of only fifteen monuments remaining from the Ayyubid Period. A view of the base of the minaret looking from the remains of the interior of the madrasa is shown in figure 4-17. There is little lateral support at the base of the minaret since the madrasa is no longer present. The remnant unreinforced masonry walls are evident.

**FIGURE 4-17** Base of Minaret of as-Sālih Negm ad-Din Ayyūb  
looking north from remains of madrasa
